GULLY EROSION IN ANAMBRA STATE: CAUSES, EFFECTS AND MANAGEMENT APPROACH

Ogbuefi L.I. and Ijeomah, O.K

Reference to this paper should be made as follows Ogbuefi L.I. and Ijeomah, O.K (2018). Gully Erosion in Anambra State: Causes, Effects and Management Approach. *J. of Environmental Science and Resources Management* Vol. 10, No. 1, Pp. 64-85

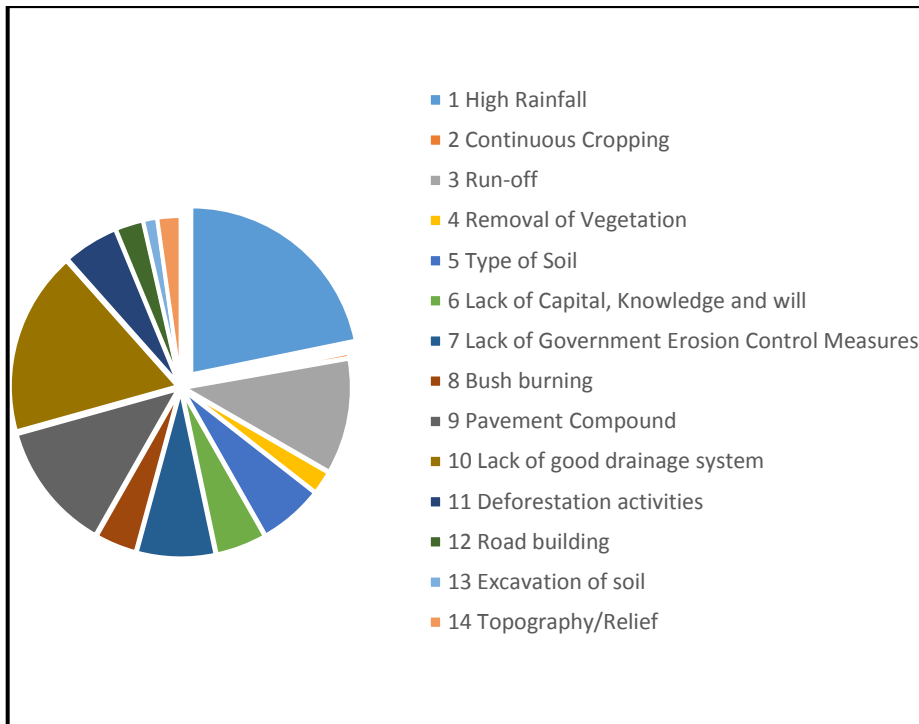
Pie Chart Representation of Table 3.
Source: Researchers' Analysis, 2018.

However, the major causes of gully erosion from the survey were high rainfall (21.9%), lack of good drainage system (17.8%), self-effort by residents towards erosion control like pavement of their compounds (12.5%), run-off (11.2%), lack of government erosion control measures (7.6%), lack of capital, knowledge and will (4.9%), etc. In addition to the responses from semi-structured questionnaires, field observations also revealed that there is a serious poor land use planning in the State. Extant literature on the history of gullies in Anambra revealed that gully areas lie on sloppy land and are distressed from land use activities.

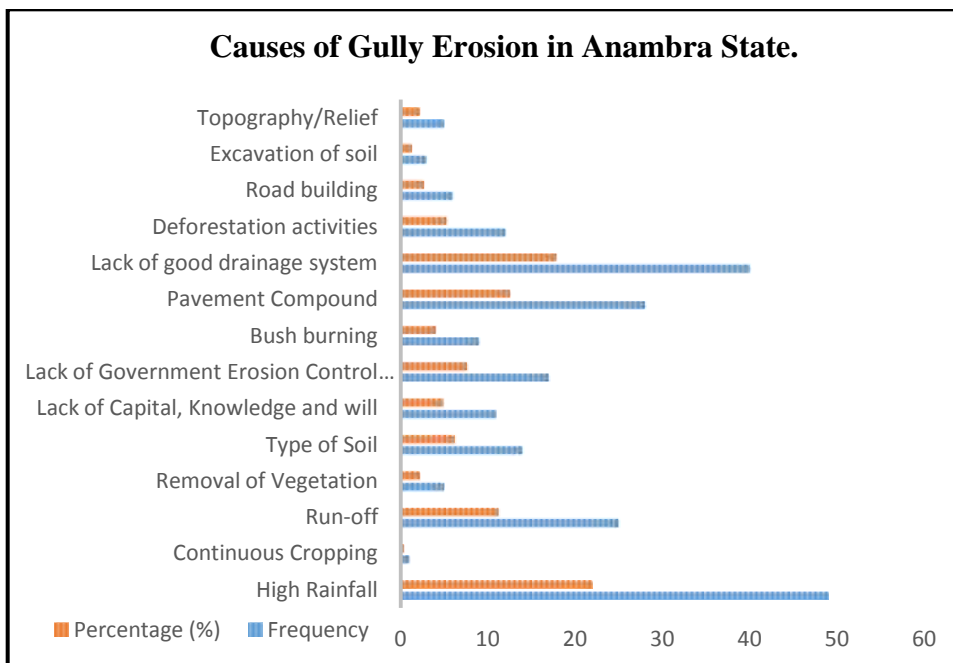
Bar Chart Representation of Table 3.
Source: Researchers' Analysis, 2018.

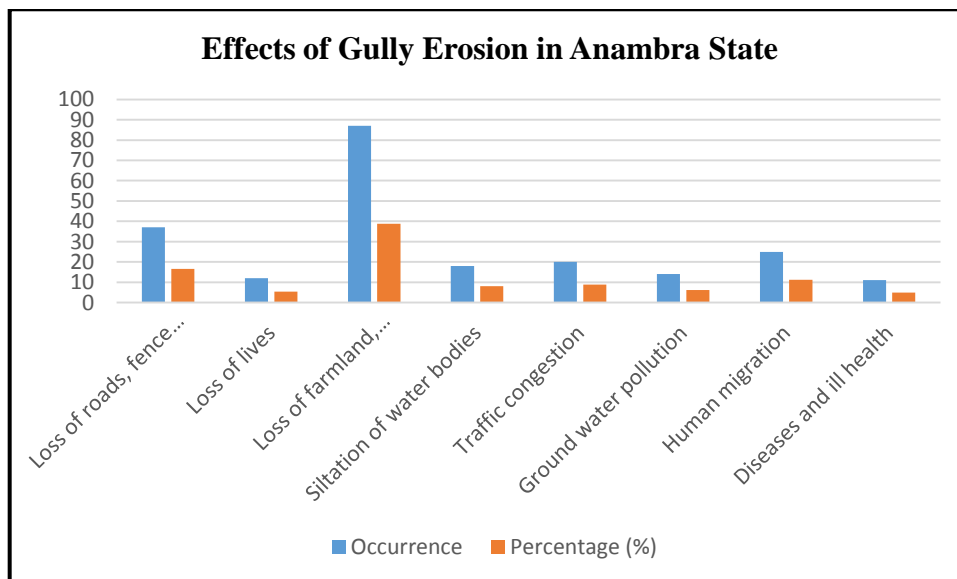
Bar Chart Representation of Table 4.

Table 4 revealed that gully erosion in the State has seriously led to loss of farmland, soil fertility and agricultural productivity (38.8%), loss of building and fenced properties (16.5%), involuntary human migration (11.2%), traffic congestion (8.9%), siltation of water bodies (8.0%), ground water pollution (6.2%) and loss of lives (5.4%). this observation is in line with the views of Yitbarek et

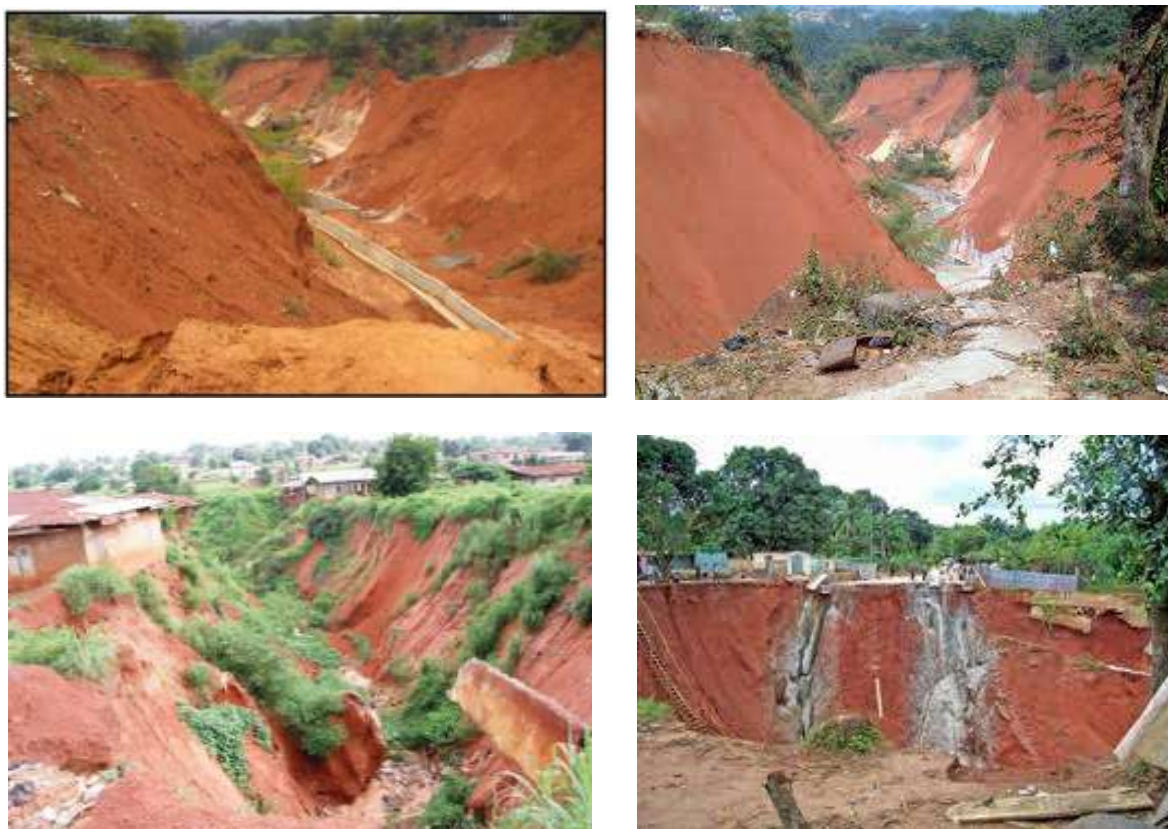
Plate 2: Photo Gallery of Gully Erosion Menace in some parts of Anambra State, Nigeria.

The investigation utilized personal observation methods and some pictures were taken to demonstrate the reality of erosion menace in Anambra State, and are presented in Plates 1 and 2 respectively.
